I am writing to you as a follow-up to a conference call held on October 4, 2006 regarding two new studies of the Suncook River in Epsom, New Hampshire. This letter is designed to provide the documentation that you requested so that the Federal Emergency Management Agency (FEMA) can make a determination if the studies can be supported under the Hazard Mitigation Grant Program (HMGP) which was authorized under Section 404 of the Robert T. Stafford Disaster Relief and Emergency Assistance Act.

In June of 2006, the USGS submitted a concept proposal to the Federal Emergency Management Agency (FEMA) and the State of New Hampshire to conduct a flood study along the Suncook River in Epsom, NH. This proposal was submitted at the request of the New Hampshire Department of Environmental Services (NHDES) and the New Hampshire Office of Emergency Management (NHOEM) in response to the May 13-16, 2006 flooding in New Hampshire that resulted in a breach (located south of Route 4 and east of Route 28) in the bank of the Suncook River that caused the river to follow a new path. This breach caused the river to form a new channel upstream of both Bear Island and two dams located at the north end of B

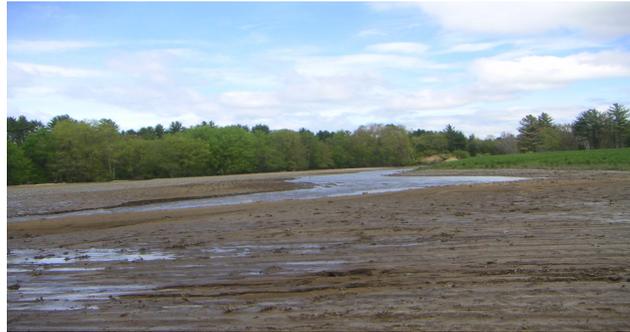
The new channel of the Suncook River along with the deposited silt and sand, has impacted 41 acres of cropland, 4 acres of forest and 22 acres of pasture (Town of Epsom, 2006). The Suncook River now flows through a former cornfield (figure 1, Orff, May 23, 2006). The sandy to silty glacial lake and stream sediments at the avulsion site and upstream will continue to erode and supply large amounts of sediment to the river and the former cornfield.

Figure 1. Suncook River's path through a cornfield due to the May 2006 flooding (Orff, 2006).

New flood mapping would determine areas of the current agricultural fields that would be inundated when future flooding occurs.
